Desert Chapel of Poured Concrete

Plastic Form Liners Make Their Bow

Put Crack Prevention On Your Construction Schedule

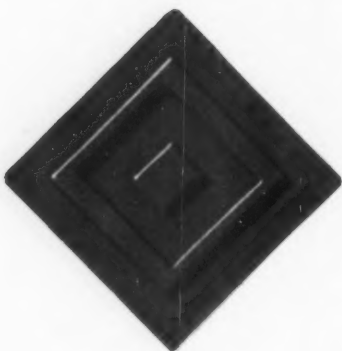
WE KNOW the head for this article smacks somewhat of a carnival barker's line, but here's a new development which calls for an enthusiastic announcement. Just placed on the market is a plastic form liner material which produces a concrete surface of unbelievable smoothness.

Without exception, everyone who has seen panels made with the liner has been amazed at the finish. Many comment on its similarity to glazed surfaces. The most appealing part of all is that the surface is achieved without resorting to any special mix or kiln curing.

Called Lustreform No. 2900, the lightweight material can be easily formed into any suitable pattern. Patterns can be of wood, plaster or glass with wood seeming the best choice for most designs. It has been found advisable to follow a few rules for

Greatest success has been had so far with horizontal surfaces either precast on the site or factory precast. Cast-in-place vertical work has been troublesome since air tends to collect in the crevices of the liner and cause voids. This doesn't seem an insurmountable problem, however, and no doubt some simple means to overcome it will be found.
